# Manhole Inspection Summary

Manhole # S41U\_\_001MH

Record Plat: **41U** Node: **001** Status: **Found**

Insp Date: **10/10/08 11:00 AM**

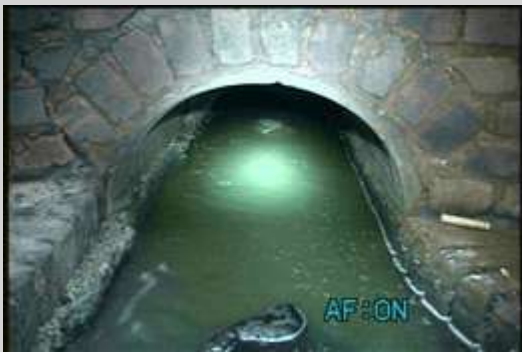
12 O'Clock Outflow

18 in. Circular Gravity Sewer  
Pipe Out @ 12 O'Clock

Pipe Material: **Clay** ☐ Pipe Lined

Invert Depth: **6.58** (ft.) Flow Characteristics: **Fast**

Deposits: ☒ None ☐ Mud ☐ Sludge ☐ Debris ☐ Grease

Infiltration: **None** Pipe Seal Cond: **Unknown**

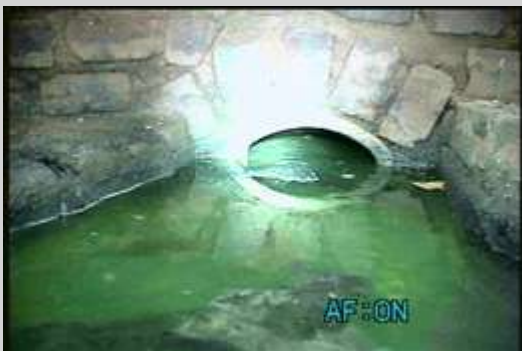
4 O'Clock Inflow

8 in. Circular Gravity Sewer  
Pipe In @ 4 O'Clock

Pipe Material: **Clay** ☐ Pipe Lined

Invert Depth: **6.25** (ft.) Flow Characteristics: **Fast**

Deposits: ☒ None ☐ Mud ☐ Sludge ☐ Debris ☐ Grease

Infiltration: **None** Pipe Seal Cond: **Unknown**

Connects To: **Dead End**

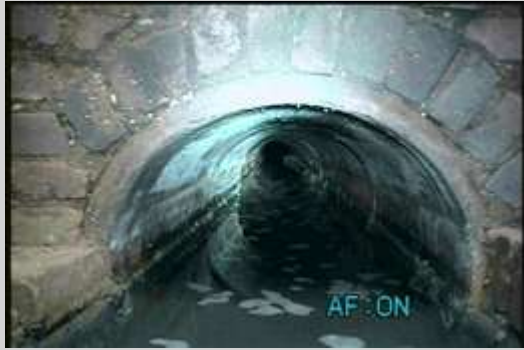
6 O'Clock Inflow

18 in. Circular Gravity Sewer  
Pipe In @ 6 O'Clock

Pipe Material: **Clay** ☐ Pipe Lined

Invert Depth: **6.33** (ft.) Flow Characteristics: **Fast**

Deposits: ☒ None ☐ Mud ☐ Sludge ☐ Debris ☐ Grease

Infiltration: **None** Pipe Seal Cond: **Unknown**
